Manhole Inspection Summary

Manhole # S43M__036MH

Inspection ☐ Is Incomplete Rating: **3) Fair**

Location Address: **1641 lancaster st**

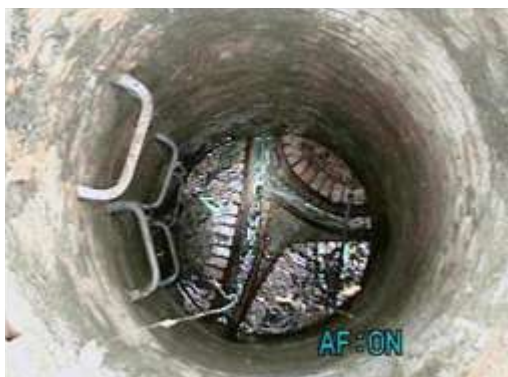
Defect 2

☒ **Evidence Of Surcharge** Depth: **2** (ft.) ☐ Active Surcharge Present

surcharge evidence

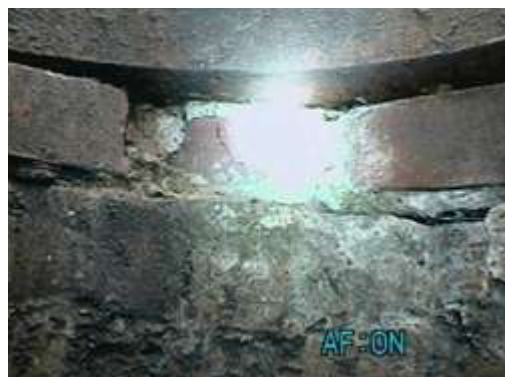
Defect 1

Condition: ☐ Sound ☐ Cracked ☐ Root Intrusion ☒ **Loose Brick** ☐ Deteriorated

loose brick in chimney

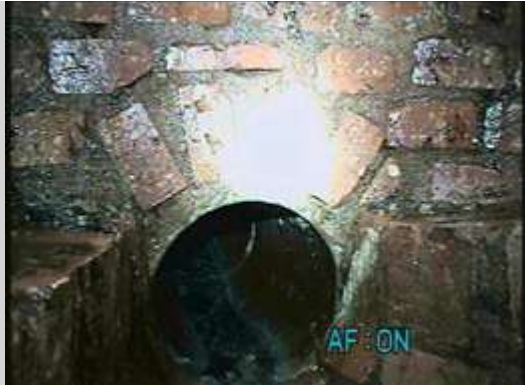
12 O'Clock Outflow

8 in. Circular Gravity Sewer
Pipe Out @ 12 O'Clock

Pipe Material: **Clay** ☐ Pipe Lined

Invert Depth: **12.38** (ft.) Flow Characteristics: **Fast**

Deposits: ☒ None ☐ Mud ☐ Sludge ☐ Debris ☐ Grease

Infiltration: **None** Pipe Seal Cond: **Unknown**

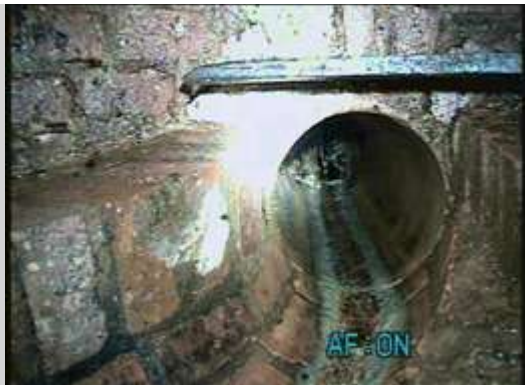
3 O'Clock Inflow

8 in. Circular Gravity Sewer
Pipe In @ 3 O'Clock

Pipe Material: **Clay** ☐ Pipe Lined

Invert Depth: **12.08** (ft.) Flow Characteristics: **Fast**

Deposits: ☒ None ☐ Mud ☐ Sludge ☐ Debris ☐ Grease

Infiltration: **None** Pipe Seal Cond: **Unknown**

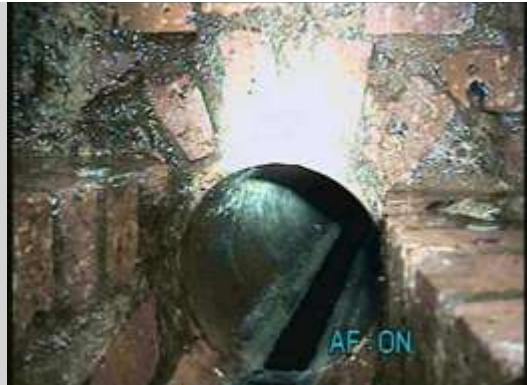
6 O'Clock Inflow

Pipe In @ 6 O'Clock

Pipe Material: **Clay** ☐ Pipe Lined

Invert Depth: **12.05** (ft.) Flow Characteristics: **Fast**

Deposits: ☒ None ☐ Mud ☐ Sludge ☐ Debris ☐ Grease

Infiltration: **None** Pipe Seal Cond: **Unknown**
